“SENATOR SERIES CHANGES”

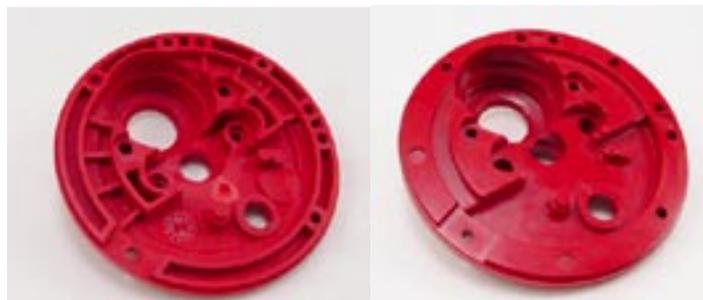
1. 113H and 114H Side Plates (001 113H; 001 114H)

Several years ago, we switched from compression molded plates to injection molded plates. This caused two major problems - 1) Screws continually backing off in the bridge, and/or 2) Anti-reverse failures - so we have gone back to the original compression molded plates which are more rigid than the injection molded plates. This change took effect in June, 2001 and the part numbers remain the same (see above). See pictures to the right to determine how to identify the compression molded plates from the injection molded plates. Send your old injection molded plates back to Penn and trade for new compression molded plates.

**Injection Mold
Incorrect**

**Compression Mold
Correct**

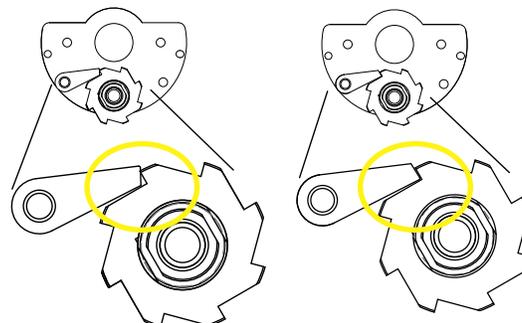
6. Anti-Reverse Dog Assembly

Incorrect

Correct

The anti-reverse in all Senators may malfunction if the dog was assembled or repaired upside down (see picture). If you are experiencing an anti-reverse problem, check and see if the dog is right side up.

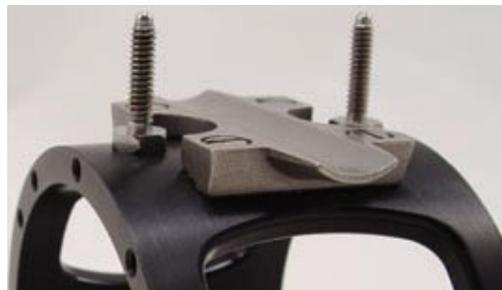
9. Rod Clamp Screws 114 Series

We have changed the rod clamp screws in the 114 Series from (034 114HLW) to (034 010KG). This change took effect August, 2003. The new screw has more thread length engaging with the frame. However, the old (034 114HLW) screws should still be used in older aluminum half frame reels that have a cast stand (see picture to the right). Additionally, the 033C114H kit is being replaced with the 033C114HF kit.

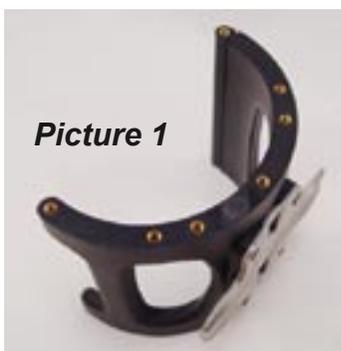
Picture 1

We have received numerous complaints concerning screws or inserts stripping out of frames. The original threaded inserts were pulling out of the frame (see picture 1 below). We started using the self tapping screws to correct this problem (see picture 2 below), but they stripped out as well. We have now corrected both problems. We no longer use the self tapping screws. We have gone back to the insert design but we have redesigned the shape of the inserts to give them more bite into the frame (see picture 3 below). This change took effect December, 2003. Here are the changes to the part numbers:
