Spinfisher 420SSG and 430SSG Bail Spring Issue

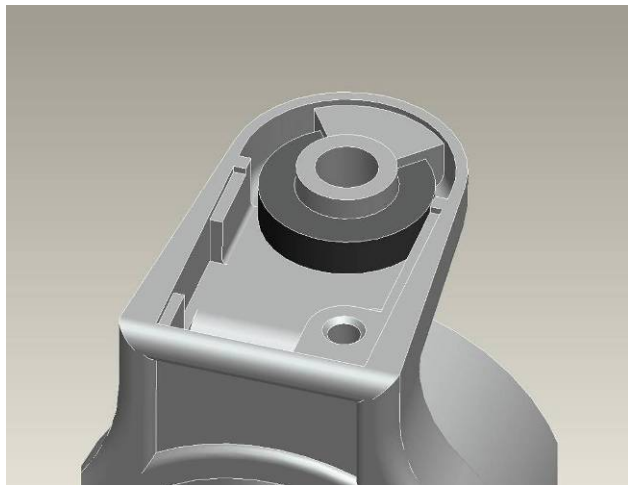
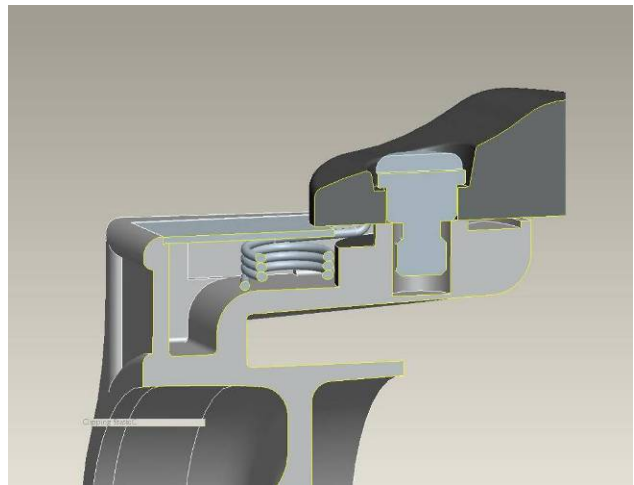
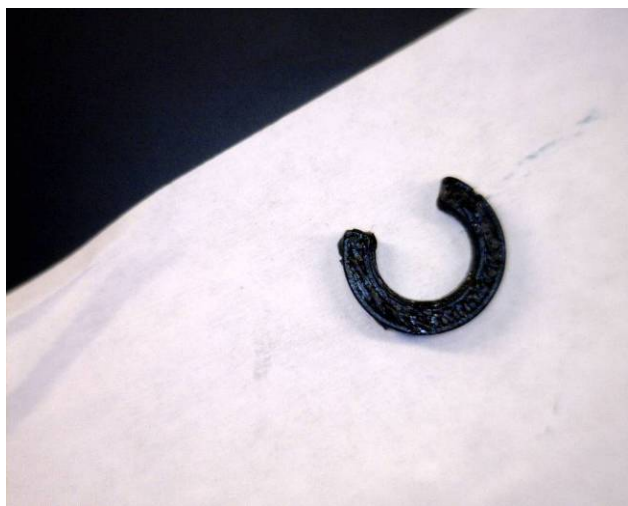
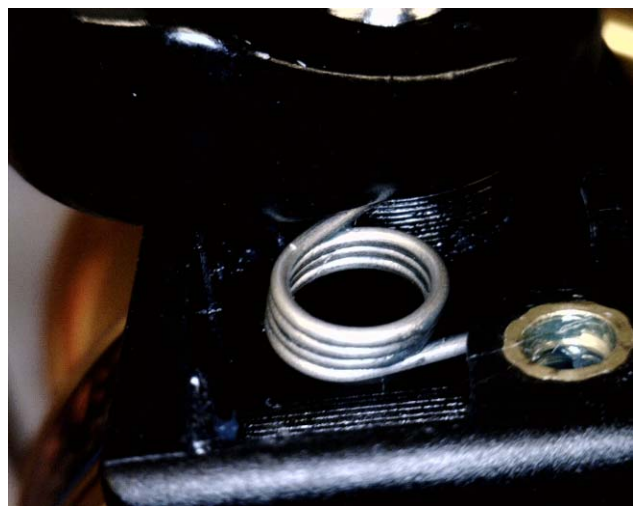
A repair part has been created (032A420G Bail Spring Spacer) that installs in the rotor arm so that the torsion spring leg is supported and will not back out of the bail cam. The spacer fits snugly around the support post and does not need special tools or adhesive.

This allows service centers to quickly repair the reel without replacing the entire rotor assembly.
